# Manhole Inspection Summary

Manhole # S04AA2023MH

**Location** Address: **3608 CLARINTH RD** Cross Street: **WILLIAMSON AVE**

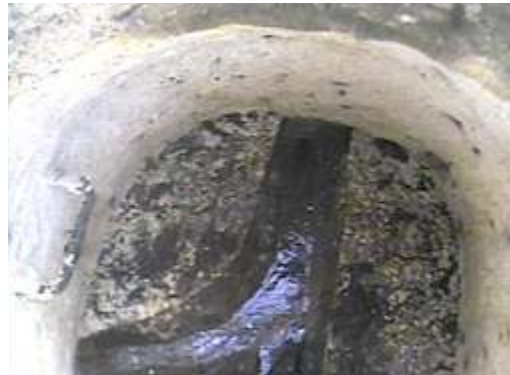
Top View

Bench debris.

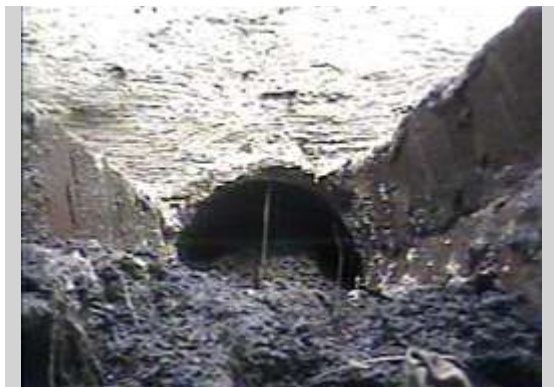
Pipe In @ 6 O'Clock

Comments **The I6 pipe picture shows Channel debris as well as heavy Pipe deposits.**

Deposits: ☐ None ☐ Mud ☐ Sludge ☒ **Debris** ☐ Grease

Silt Depth: **2** (in.) Deposits Extent: **Heavy**

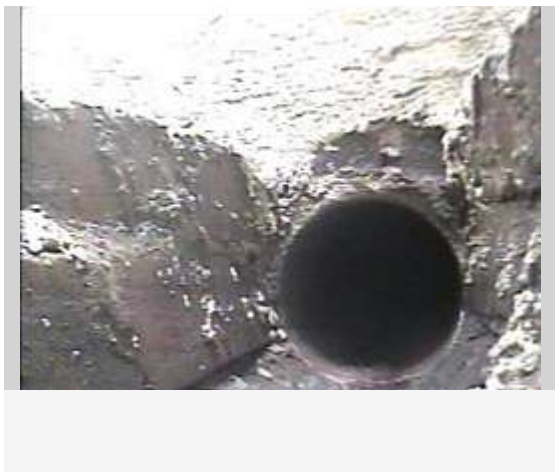
6 in. Circular Gravity Sewer  
Pipe In @ 9 O'Clock

Infiltration: **Evidence** Pipe Seal Cond: **Unknown**
